The Locomotive

THE HARTFORD STEAM BOILER INSPECTION AND INSURANCE CO.

VOL. XXXVI.

INDEX TO VOL. XXXVI.—1926-1927

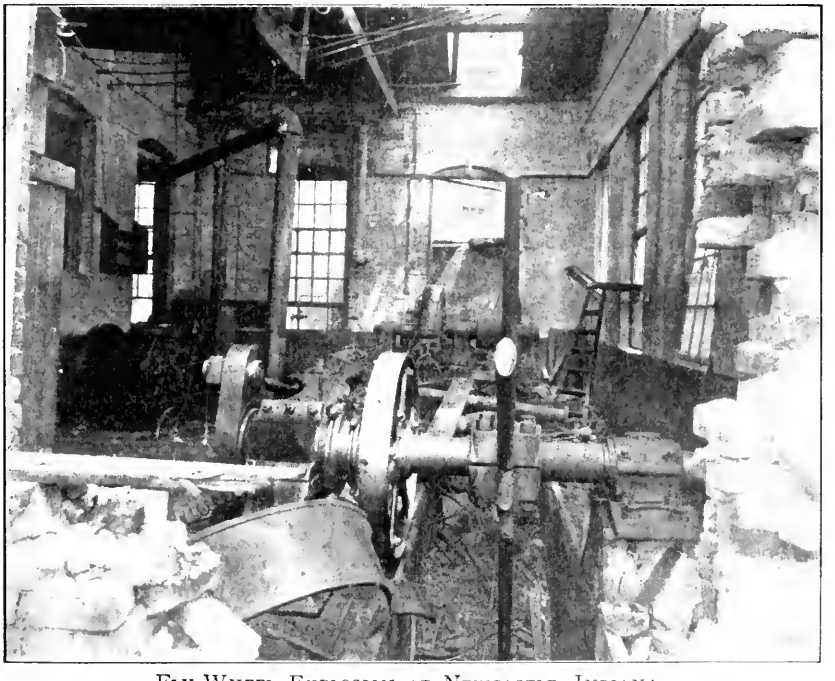
Fly-Wheel Explosion at Newcastle, Indiana.

One piece of the rim, about 3 ft. in length, flew over the three story main factory building and landed in a garden across the street. Another piece, about 2 ft. in length, was found in a field approximately 500 ft. from the plant. A man sitting on his front porch just across the street from the factory saw the flying fragments in the air and estimated that one piece ascended to a height of at least 200 ft. A hole 9 ft. by 50 ft. was torn in the roof of the engine room, and the windows and parts of the walls in line with the wheel were demolished. One arm of the wheel passed through the roof of the fire-pump house nearby and embedded itself 2 ft. in concrete. Several fragments of the wheel passed through the windows and south wall of the main factory building located 60 ft. from the engine room, breaking down some heating coils and two sprinkler pipes. Water from the sprinkler lines damaged finished pianos and materials in process of manufacture, and led to a newspaper estimate of the loss at $40,000. Prompt action by factory employees in moving pianos and other contents minimized the damage. In such a bombardment by large and small pieces of iron, it is remarkable that no one was injured.

After the accident one of the governor springs was found to be broken and it is thought that this failure might have occurred before the explosion and caused the governor to become inoperative. The engine frame was broken near the main bearing pedestal and the foundation was so cracked and broken as to necessitate rebuilding. In addition the connecting rod was badly sprung, the eccentric rod broken, the rocker arm cracked, and the governor completely ruined. Some of the coils of the generator were damaged and the generator pulley demolished.

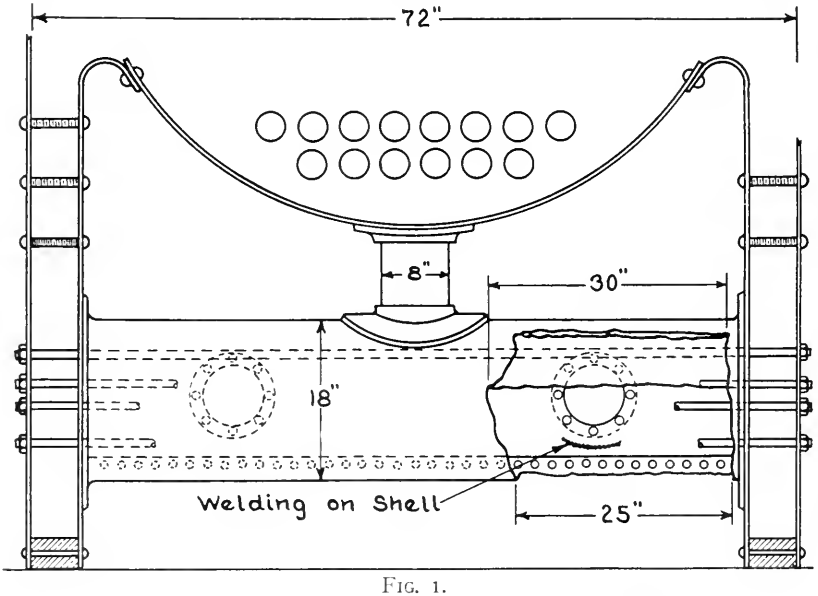
FIG. 1.

the fire box and combustion space are enclosed by water-legs which run along each side of the boiler for its full length. These water-legs are connected near the center by an 18 inch diameter circulating cross drum, which serves also as a bridge wall. This drum has an 8 inch diameter vertical connection to the boiler shell and two 6 inch diameter horizontal connections to the wet-back at the rear of the combustion chamber, as indicated in Fig. 1.

The failure was in the circulating cross drum of the forward boiler. Leakage in this drum had become evident and repair men from a local boiler shop were called in to weld the leak before the boat left Pawtucket on the morning of the accident. The welders reported a crack about 7 inches long near the longitudinal seam, which they were unable to repair because of lack of room and too much moisture from the leak; so that the boat set out for Newport, forty-five minutes late and with only the aft boiler, which had not been giving trouble, under steam.

A fire was later started under the forward boiler and the return trip begun about 5:30 P. M. with both of them in operation at reduced pressure. When but a short distance out from Newport the circulating cross drum of the forward boiler failed. The rupture began at a line about 25 inches long parallel and very close to the longitudinal seam — which was near the bottom of the drum on the side away from the grates — and tore a strip of this width circumferentially

around more than one-quarter of the drum. The nature of the failure is clearly shown in Figs. 1 and 2. The piece marked "B" in Fig. 2 is the torn part of the drum shell. The piece marked "A" had no connection with the boiler.

The cause of the failure was external corrosion. External corrosion is a wasting away of the outside surface of the boiler, accelerated usually by the presence of moisture and soot. Sometimes the moisture comes from the boiler itself through a leak, and sometimes from other sources such as leaky valves or fittings in overhead pipings. Sometimes it may be produced by the sweating of a cold boiler, or perhaps by exposure to the elements. Deposits of soot, usually in comparatively inaccessible places which are likely to be slighted when cleaning the exterior of the boiler, retain this moisture and, by reason of the composition of soot, almost invariably result in corrosion of the plate which, if not checked, will soon become dangerous. The original thickness of the plate of the ruptured drum in this case was ⅜ inch, but it had been seriously reduced by the corrosion. The reduction in thickness of the shell began on a line running parallel to the axis along the lowest part of the drum and increased toward the seam, tapering off sharply to practically a knife edge at the line of initial failure. The defect — variously reported as "pin holes" and a "crack" — that prevented full use of the boiler just prior to the accident was evidently a place where the corrosion had penetrated through the plate. This wasting away of the place, however, had been so uniform and so free from signs of pitting or grooving that, except where it had actually penetrated through, there were practically no visible indications that the plate was dangerously thin.

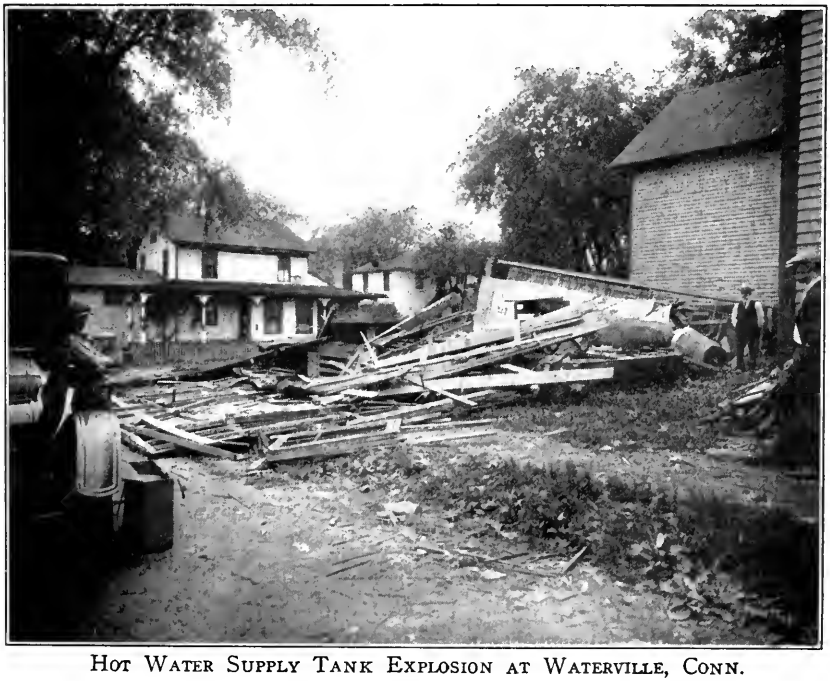
Hot Water Supply Tank Explosion at Waterville, Conn.

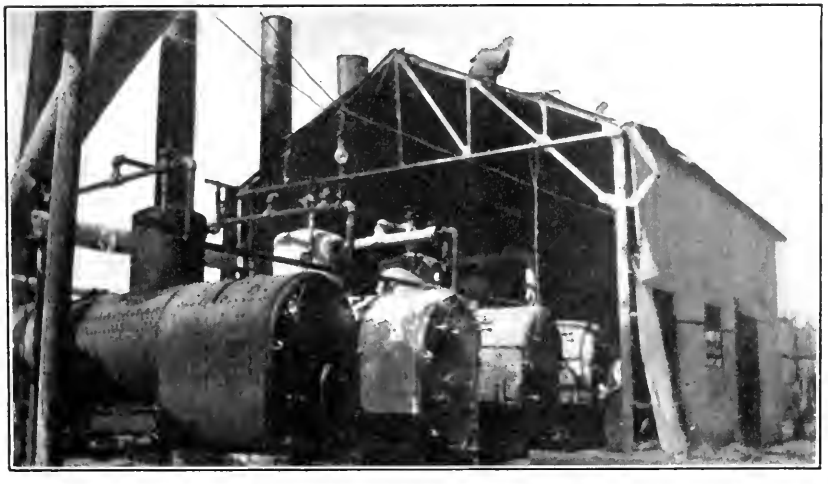
FIG. 1.

about 50 ft. from its foundation. About half of the boiler house was wrecked. Fig. 1 shows the scene of the accident after a new boiler had been installed in place of boiler No. 1 but before the boiler house had been rebuilt. Fortunately no one was injured in this accident. The property loss was approximately $2,500.

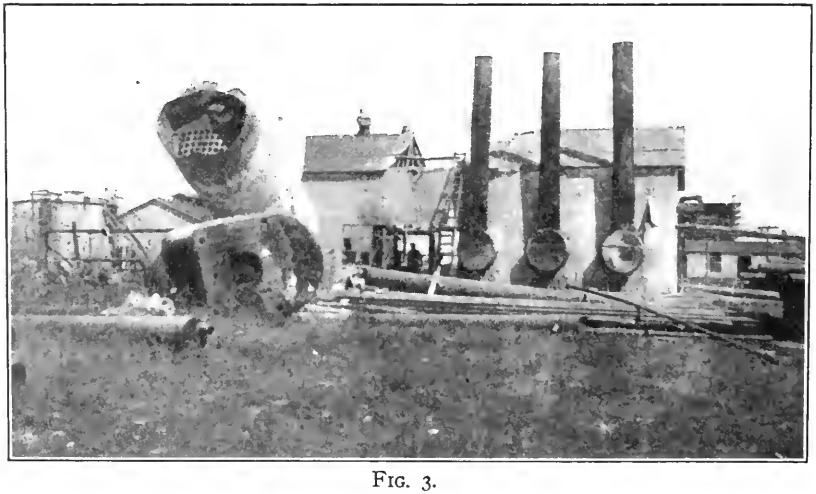
FIG. 3.

A little over two months later boiler No. 4 in this group exploded. As in the previous instance, the cause was low water. The crown sheet dropped and the boiler hurtled out of the house. By a peculiar twist of fate, it came to rest partly on top of the one that had exploded before. The two boilers are clearly shown in Figs. 2 and 3 just as they landed. Again no one was injured. The property loss amounted to $1,700.

As previously stated, the direct cause of each accident was low water. This was quite apparent from an examination of the boilers after the explosions, but the cause of the low water is not so apparent. The boilers were subject to inspection and the gauges and appliances were found to be kept in good condition. The presence of a feed water regulator suggests the possibility that too much dependence was

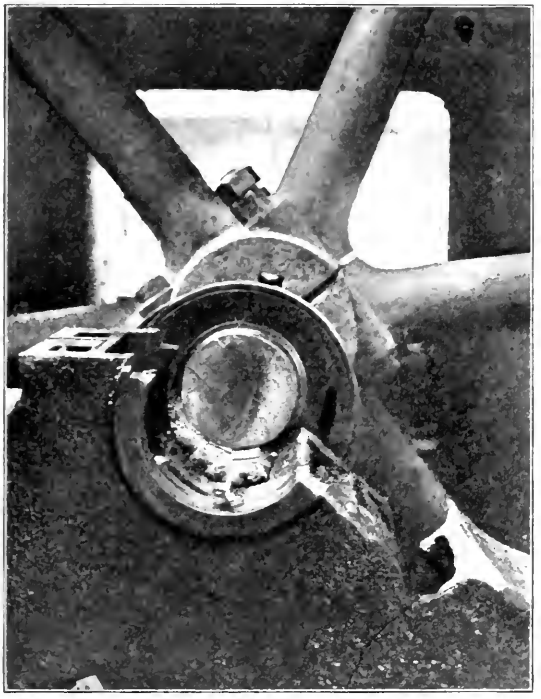
SHOWING HOW AN OLD CRACK HAD PENETRATED APPROXIMATELY 70% OF THE CROSS-SECTION OF AN ENGINE SHAFT.

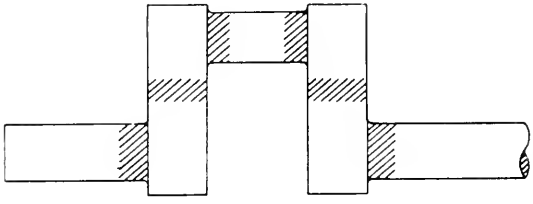
FIG. 2.
THE SHADING INDICATES THE REGIONS IN WHICH CRACKS MAY BE LOOKED FOR.

The bending stress in a shaft due to misalignment of the bearings is in addition to the normal bending stress produced by the load on the crank. The total stress thus created may in time be sufficiently high to cause gradual failure of the material. A shaft which has been subject for some time to excessive bending stress, if carefully inspected, is fairly certain to show surface cracks in certain critical portions. Such cracks generally occur in the shaded areas shown in Fig. 2.

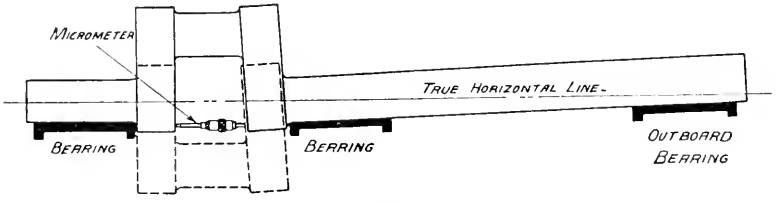
FIG. 3.
CRANK SHAFT DISTORTION DUE TO POOR BEARING ALIGNMENT (EXAGGERATED FOR PURPOSES OF ILLUSTRATION).

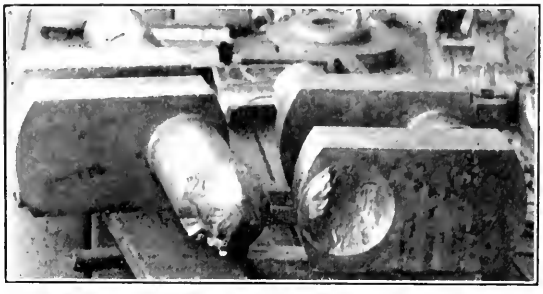
FIG. 4. BROKEN CRANK SHAFT.

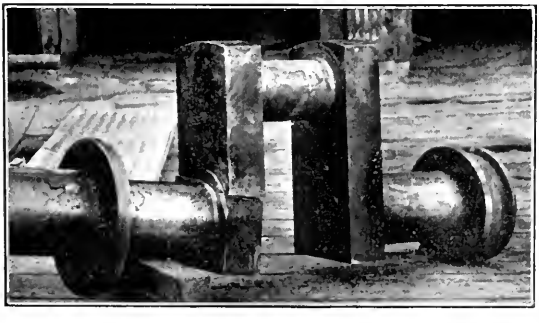
FIG. 5. BROKEN CRANK WEB.

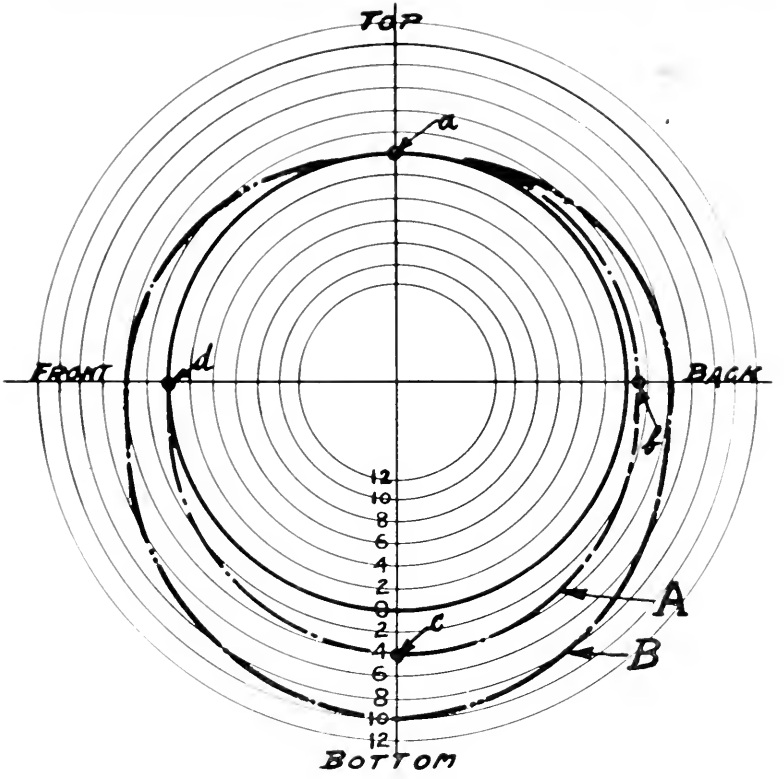
As an example, Fig. 8 is a graphical representation of conditions found in a 7-inch single-crank shaft. In this diagram the distances between concentric circles represent two one-thousandths of an inch and the heavy circle denoted by zero is taken as a reference circle. Four positions of the crank are denoted by TOP, BACK, BOTTOM and FRONT. The graph A was obtained by drawing a line through points a, b, c and d. If the first measurement between crank webs is taken with the crank in TOP position and its position assumed to be on the reference (zero) circle, then the distance of .001 inch that point b lies outside of the reference circle denotes that the measurement between crank webs, when the crank was set in position BACK, was .001 inch greater that that at crank position TOP. At point c the distance between crank webs has become .004 inch greater and at point d the distance between crank webs is again the same as it was originally at

FIG. 8. GRAPHICAL REPRESENTATION OF CRANK DISTORTION.

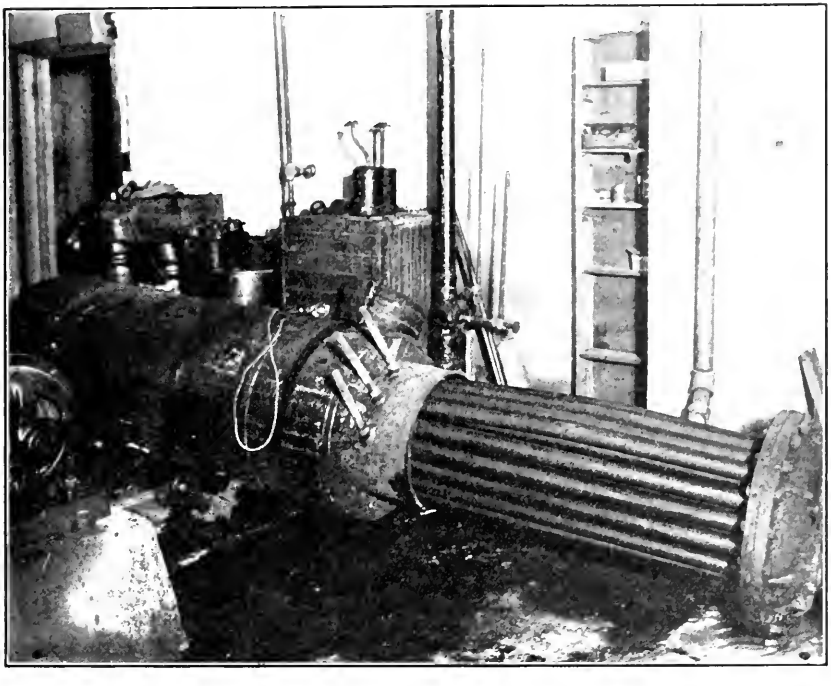
FIG. 1.

Brine Cooler Explosion At St. Louis, Mo.

A BRINE cooler exploded in the basement of the Valentino Apartments, St. Louis, Mo., on the afternoon of September 4th, 1925, killing one man and injuring six other persons. Five of the injured were overcome by fumes, and a woman was injured in jumping to the ground from a third floor window in a frantic effort to escape from the fumes.

The brine cooler consisted of a shell 20 inches in diameter by 12 ft. long with tubes running through from end to end. Brine was circulated through the tubes for cooling, and ammonia surrounded the tubes. The shell was constructed in two courses of 5/16 inch plate, and all joints were autogenously welded.

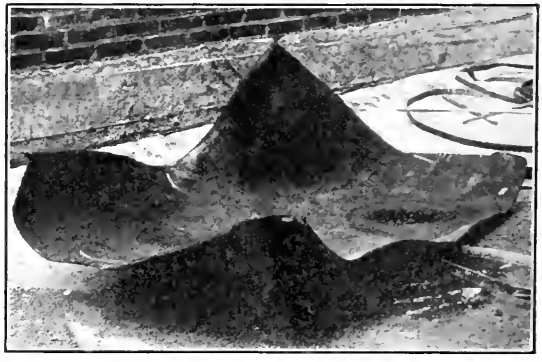
FIG. 2.

While the direct cause of the accident is thought to have been overpressure, yet it is significant, as so frequently is found to be the case, that some portions of the welding were very poor. The failure was entirely in one course, as shown by Fig. 1, and the rupture was confined to the welded seam. The course that failed was completely torn off and opened out flat, as shown in Fig. 2. Considerable damage was done to the piping and walls of the basement.

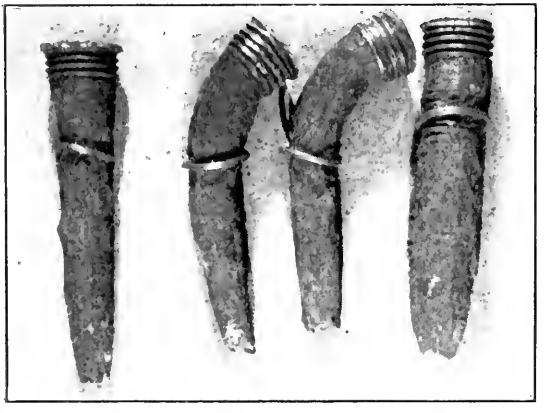
FIG. 1.

The failure of the boiler cannot be attributed to any of these repairs but rather to the failure of the staybolts. The staybolts in the boiler were originally of ¾ inch diameter, having a net cross-sectional area of .288 inch. They were spaced on 5 inch centers; hence the area supported by each bolt was 24.712 square inches. (Supported area minus area of staybolt.) The total stress allowed in a ¾ inch staybolt by the A. S. M. E. Boiler Construction Code is 2160 lbs., which when divided by the area 24.712 square inches, gives an allowable operating pressure of 87.5 lbs. At the time of the explosion the boiler is said to have had 110 lbs. pressure. The safety valve, which incidentally was too small, was set at 120 lbs. Under normal conditions, therefore, the staybolts were overloaded, and this condition was seriously aggravated by the fact that they had materially wasted away. As shown in Fig. 1, some of these staybolts had corroded to such an extent that not over one-third of the original diameter remained. This reduced the effective cross-sectional area to about one-sixth of normal and increased the unit stress in inverse proportion, thus effectually overcoming any reasonable factor of safety. During the overhauling, the hand-hole covers in the bottoms of the water legs are said to have been removed and the mud and sediment washed out, so it would seem as if these corroded staybolts must certainly have been seen at that time. However, the persons who did the work evidently failed to appreciate this to be a dangerous condition and so made no comment on it.

An examination by an expert boiler inspector would undoubtedly have revealed the overloading and wasting away of the staybolts and the insufficient size of the safety valve, and would have brought forth recommendations for suitable repairs to the throat and crown sheets. If there had been expert inspection it is very likely this accident would not have happened.

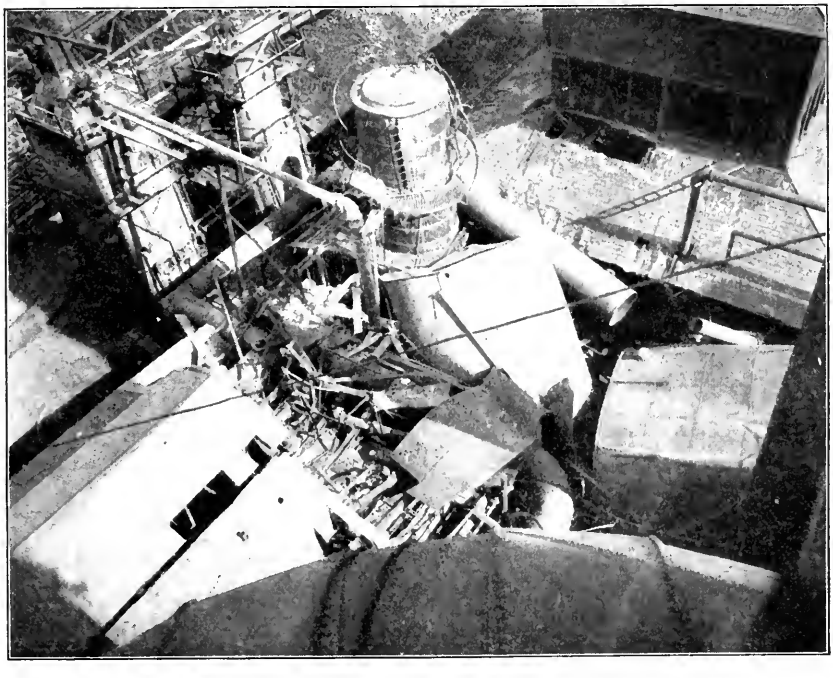
A Recent Steam Pipe Explosion.

THE explosion of an 8 inch steam pipe might not ordinarily be thought of as a very devastating type of accident but the accompanying pictures show that such an accident may at times approach a boiler explosion in destructiveness. The explosion illustrated occurred July 25, 1926. The property loss amounted to $17,-

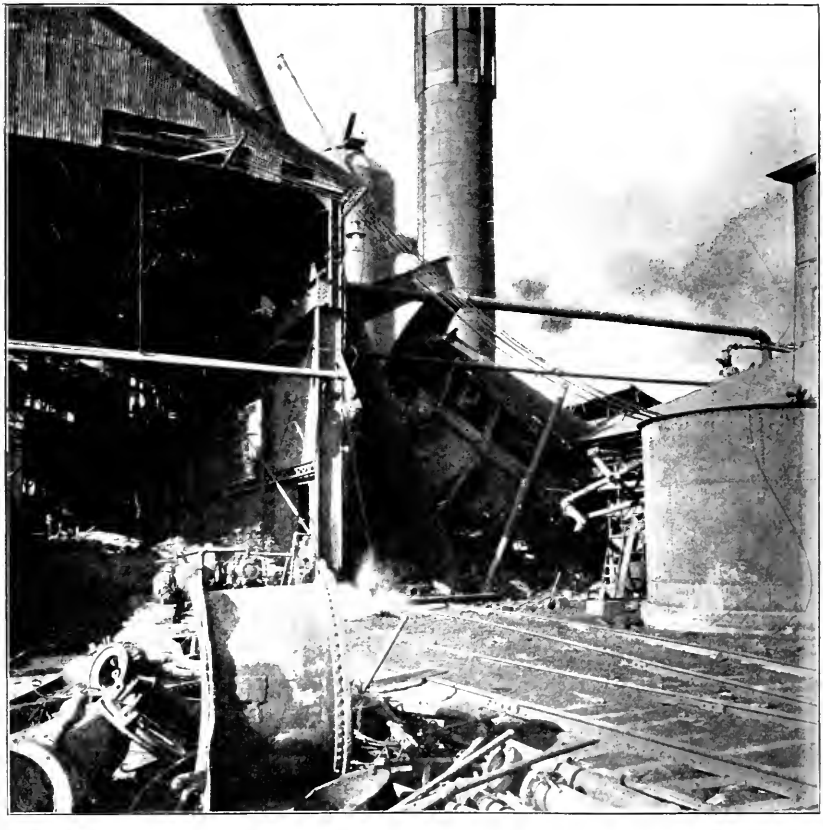
FIG. 1.

860. That no one was killed or seriously injured seems miraculous.

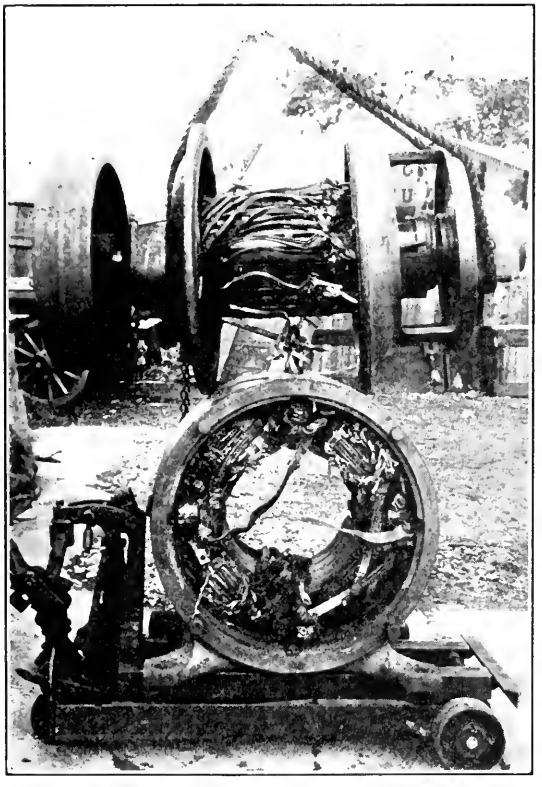
FIG. 1.

Fig. 1 is an illustration of what may happen to an automatically controlled series wound motor when the control fails to operate. This motor was used on a 10 ton hoist and overspeeded, with the result that the commutator flew to pieces, the armature wires were forced out of the slots and the field windings were completely destroyed. In fact the motor was so badly wrecked that it was not considered worth repairing and was replaced by a compound wound motor, which is not liable to this type of failure.

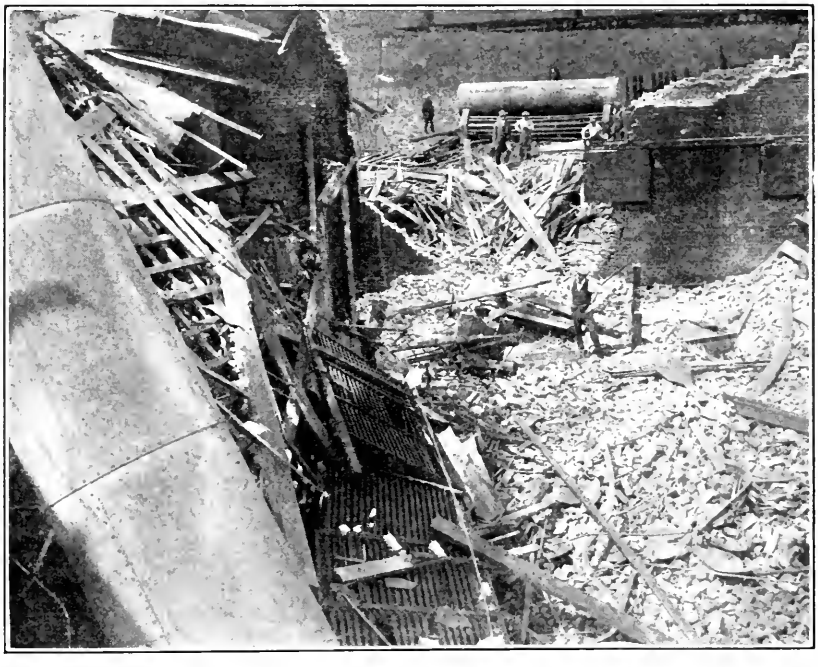
FIG. 1.

A BOILER explosion of considerable intensity occurred at the plant of the Albert David Chemical Company, Chicago Heights, Illinois, on the morning of June 15th, 1926. One man was killed and property destroyed to the extent of nearly $18,000. Greater loss of life was undoubtedly avoided because of the early hour, as the employees were just beginning to arrive and but few of them were on the premises. A few minutes later several men would have been at work in the immediate vicinity of the boiler room.

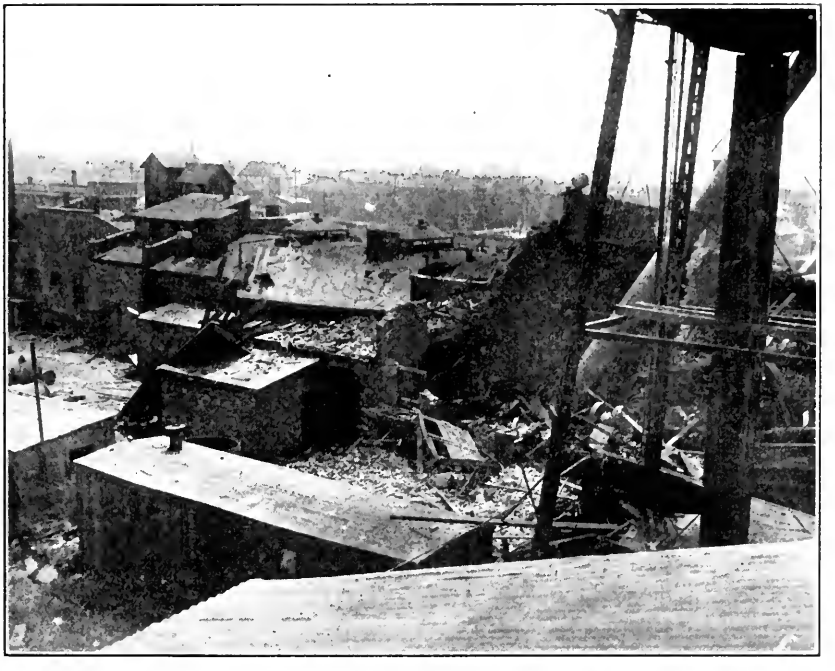
FIG. 2.

The rest of the boiler traveled almost intact through the opposite wall of the boiler house, ploughed across a railroad spur and through a fence, and came to rest about 75 feet away in a field. The boiler was somewhat battered by contact with the wall and railroad track, but the only rupture was in the head. The setting of an adjoining horizontal tubular boiler was damaged, and the stack and all of the piping in the boiler room were torn down when the building collapsed. An air compressor and a large drill press in the engine room were completely destroyed, and

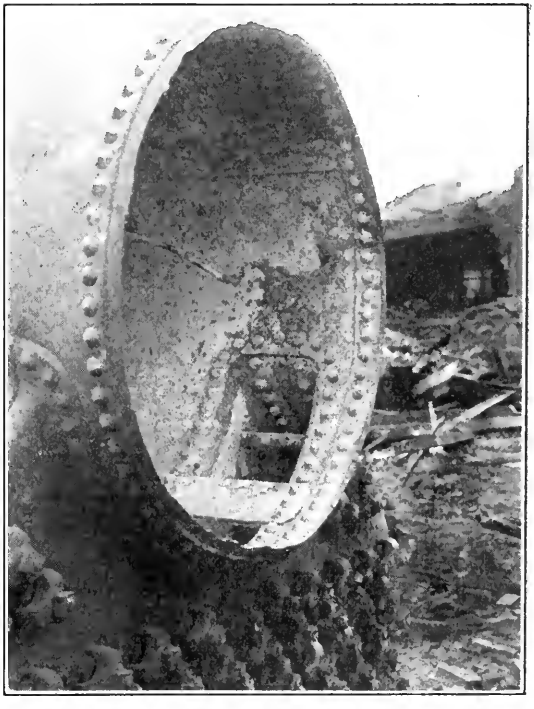
FIG. 3.

The cause of the explosion was a cracked head. As can be seen from Fig. 3, the head was severed completely around its circumference along a line about 2 inches from the row of rivets and just at the turn of the flange. Examination of the material along this line of rupture shows that a crack had developed extending almost completely around the head. Cracks such as this in the heel of a flange are generally regarded as fatigue failure of the metal. The exact pressure of steam at the time of the accident is not known.

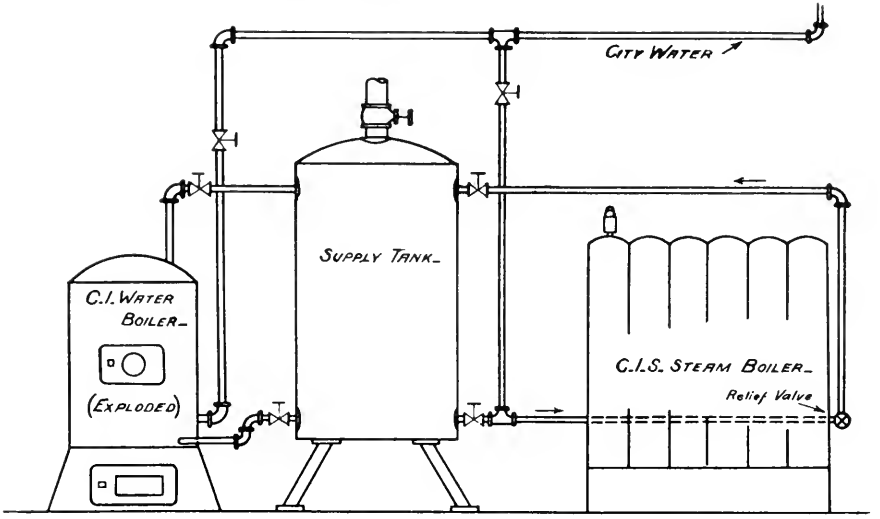
Fig. 1.

A CAST iron hot water supply boiler exploded in Baltimore, Maryland, on December 28th, 1925, under peculiar circumstances in view of the fact that it had never been fired up since it was installed. The boiler, which was constructed for a maximum water pressure of 60 lbs., was connected to a steel supply tank and also to a pipe heating coil in the firebox of a cast iron steam heating boiler, as shown by the accompanying sketch.

The heater was not equipped with the regulation water relief valve nor had it a pressure gauge, thermometer or temperature regulator. However, there was a relief valve fitted on the inlet pipe leading to the pipe coil in the firebox of the steam boiler. The relief valve was stamped to release at 125 lbs. pressure, while the normal city water pressure was 85 lbs. It will be observed that stop valves are fitted in all pipe connections between the boiler and the relief valve.

The cause of the explosion is thought to have been the freezing of the water in the feed pipe where it passed through the stable floor above. About 5 o'clock on the morning of the accident a quantity of hot water was drawn from the system to replenish an automobile radiator, and at the same time the fire in the steam heating boiler was freshened up. This generated steam in the heating coil and increased the pressure to such an extent that the weakest part of the system, which was the cast iron boiler, exploded about 7:00 A. M., the relief valve failing to function at a pressure which would protect the hot water heater.

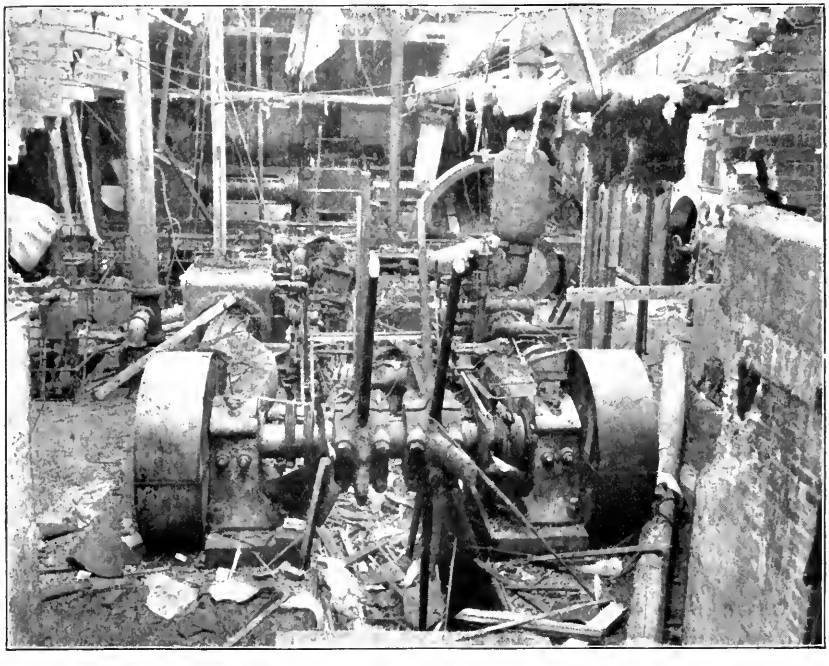
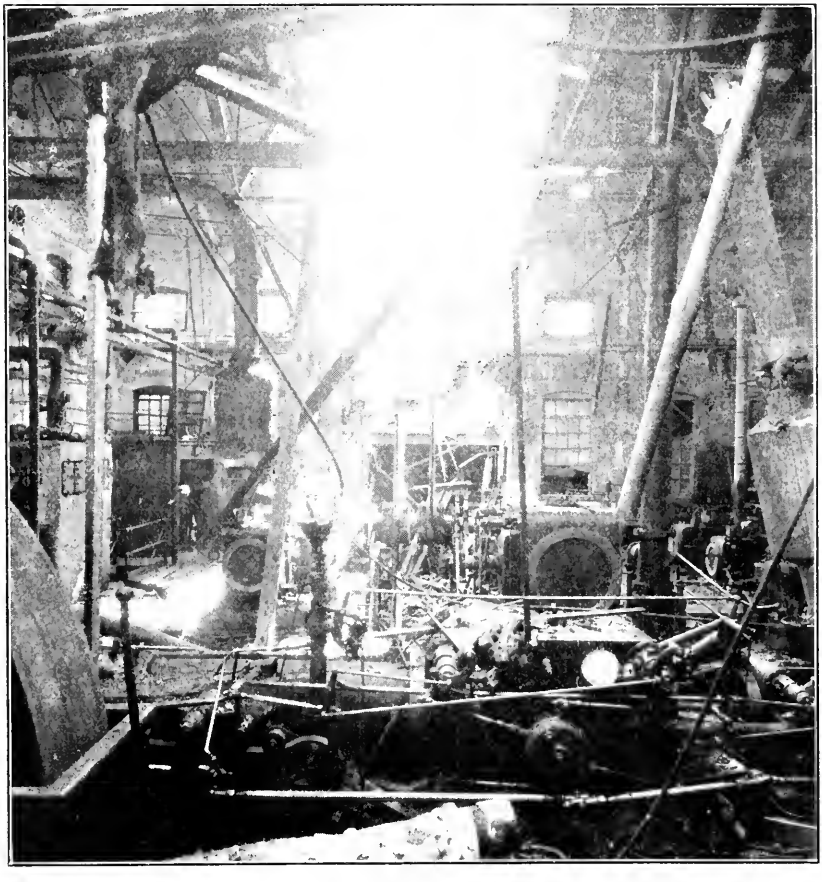
FIG. 1.

Flywheel Explosion at Kalamazoo, Michigan.

THE front cover picture and other accompanying illustrations show some of the results of a disastrous flywheel explosion that occurred July 21, 1926, at the plant of the King Paper Company Division of the Allied Paper Mills, Kalamazoo, Michigan. There was

a property loss of $26,000, and a use and occupancy loss of more than $10,000. Six persons were injured, but fortunately all injuries were of a minor character.

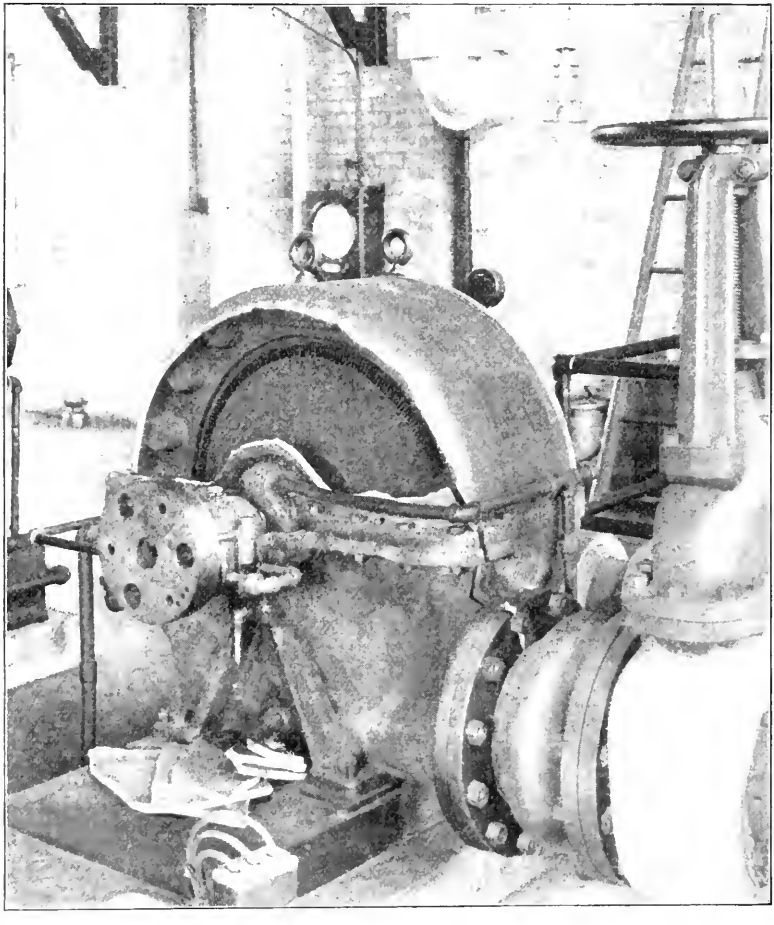
FIG. 1.

pressure supply line. Such a valve, however, introduces a hazard that is not always appreciated, for where there is a valve there is always the possibility of its being closed at the wrong time. The presence of this stop valve in the exhaust line presents the possibility of the low pressure end of the turbine being subjected to full boiler pressure. Since the low pressure casing is not designed to withstand

The explosion of a 50 kw. turbine, the results of which are shown in the accompanying picture, was due to the closing of a valve in the exhaust line under rather unusual conditions. The turbine had been in operation as usual for several hours when it suddenly lost its load and was tripped out by an overspeed safety device. This occurred during the early hours of the morning, and the plant being in darkness due to the shut down, the fireman on duty made an effort to start up the turbine again. He first closed, or endeavored to close, the throttle valve, but apparently became confused in the dark and closed the exhaust valve instead. Upon opening the valve that had been closed by the overspeed mechanism, full boiler pressure was thrown upon the turbine casing because the throttle valve had remained open. The casing was so completely wrecked and the shaft so badly sprung that the turbine had to be replaced by a new one. The direct connected generator suffered damage to several coils. Greater damage would undoubtedly have resulted if the machine had been in motion.

high pressures, it should be protected against over pressure by an atmospheric relief valve.

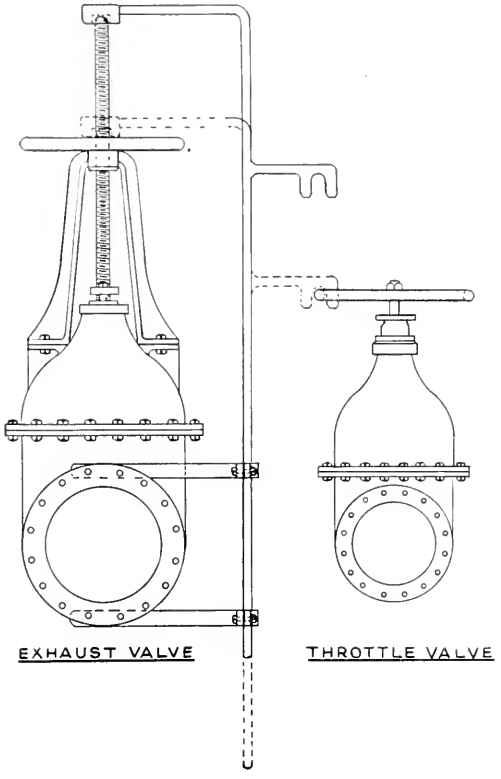
FIG. 2.

This turbine casing was not protected by an atmospheric relief valve but it did have an interlocking device connecting the steam and exhaust valves which it was thought made a relief valve unnecessary. The construction of this device is shown in the diagram, Fig. 2. A vertical sliding rod was supported by guides and contained two horizontal arms, one of which terminated in a downward projecting fork, and the other in a downward projecting cap. The cap fitted over the

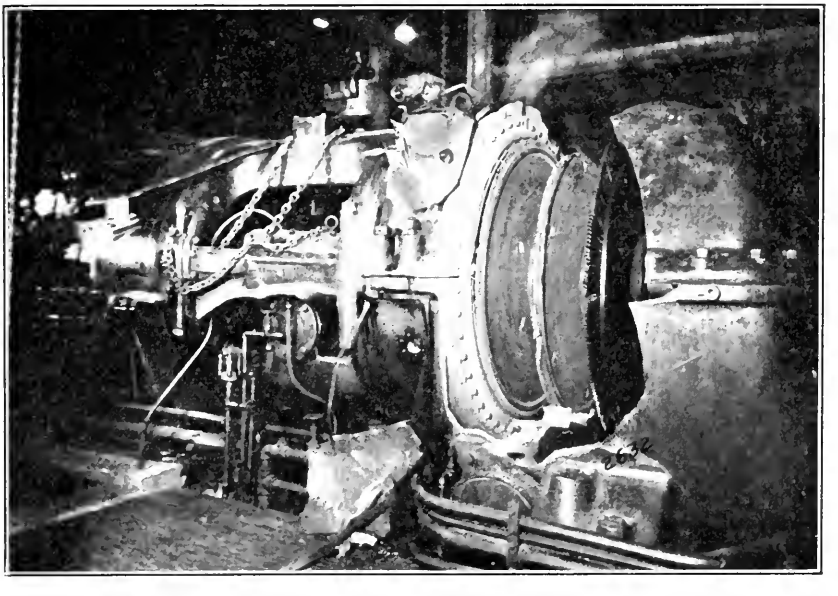
Steam Turbine Explosion at Chillicothe, Ohio.

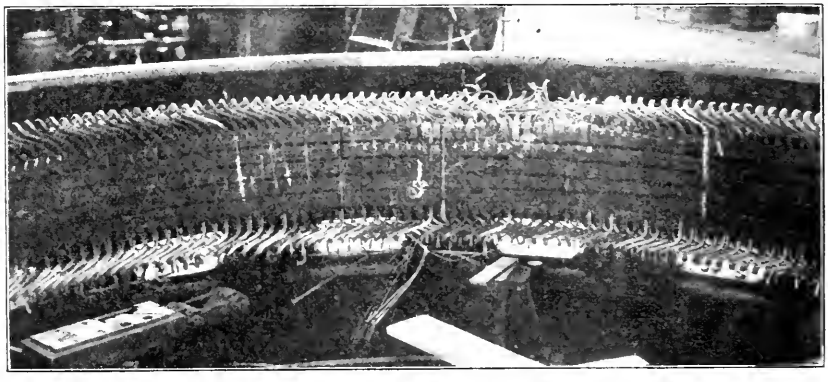
FIG. 1.

THE accompanying picture shows some of the damage resulting from the failure of a 937 kw. generator at the plant of the Keith Paper Company, Turner's Falls, Mass., on June 11, 1926. The property loss amounted to $2,700, and the use and occupancy loss exceeded $16,300. No one was injured.

The accident occurred about 12:10 A. M. when this hydraulic turbo-generator and a steam turbo-generator were carrying jointly a load of 1200 kw. The initial trouble was a short circuit or ground in the stator winding which resulted in the destruction of approximately 47 coils. Fire resulted, and it was necessary to call the city fire department to extinguish it. As a result of the fire, all of the stator coils were ruined and a complete new stator winding was required. This rewinding was estimated to take six weeks time. Through inability to use this machine production at the mill was curtailed, other generating units not being of sufficient capacity to carry the total load.

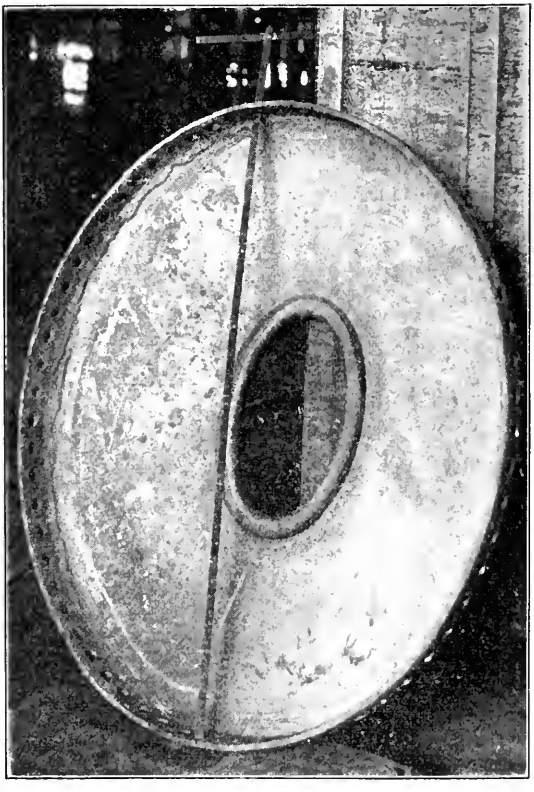
FIG. 1.

Following this alarming discovery, the other heads in this boiler and another one of the same make and age were carefully examined, and as several of them showed indications of the presence of cracks, it was decided to replace all of the heads. Subsequent examination revealed one of these heads to be in an even worse condition than the one first discovered. Although the cracks extended around only 52

inches of the circumference, yet in several places they penetrated to within 1/16 inch of the full thickness of the plate. Three other heads had cracks extending for 32, 36 and 52 inches, respectively, in a circumferential direction. The remaining three heads, while showing slight grooving, seemed to be free from cracks. These drums were 48 inches in diameter, and previous to HARTFORD inspection, the boilers had been operated between 185 and 200 lbs. pressure although they were designed for but 175 lbs.

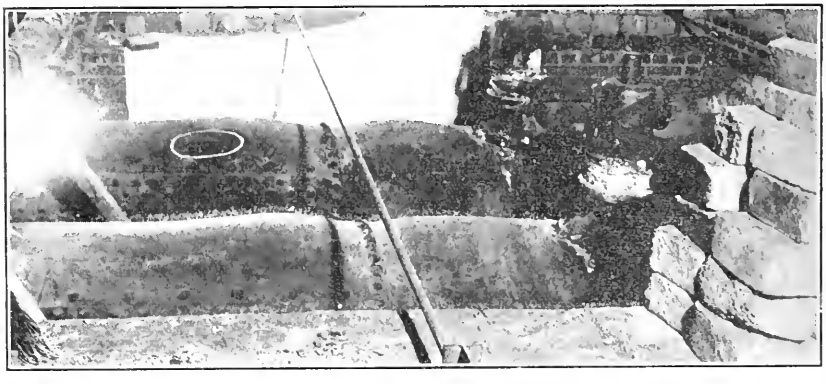
FIG. 1.

THE accompanying pictures show the progress toward destruction of several boilers under conditions that appeared at first to justify the use of the word "mysterious." The installation consisted of a battery of four horizontal two-drum water tube boilers. One drum ruptured, followed shortly by the rupture of a drum in another boiler. Examination of all of the boilers then revealed that five of the eight drums were badly bulged, as shown in the photographs.

It was quickly realized, of course, that the trouble was the result of overheating due to the peculiar design of the setting of the boilers. The brick arch did not close in on the sides of the drum at about the

lowest safe water level, as customarily is the case, but instead was carried above and suspended entirely clear of the drums, leaving a space of about 12 inches between the tops of the drums and the arch. The hot gases direct from the fire went upward among the tubes of the first pass and then surrounded the drums before going downward in the second pass. This was probably designed to provide drier steam. The heat from the gases in contact with the drums caused overheating of the plates in the steam space of the boilers, as would be expected.

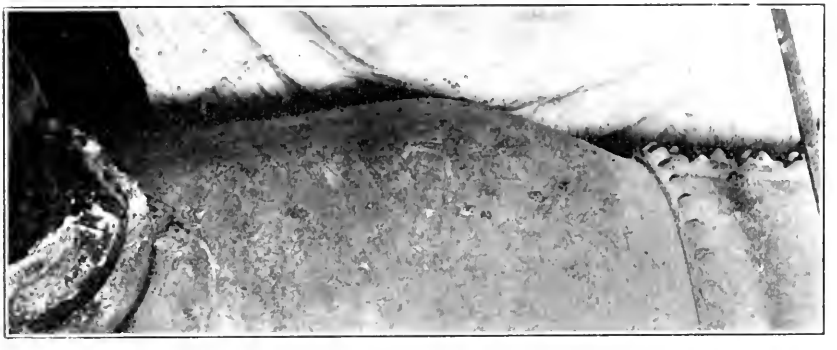
FIG. 2.

Investigation brought out that the stokers on these boilers had been changed shortly before the development of this trouble and the

new stokers increased the rate of combustion. This, of course, meant hotter furnace gases and caused overheating of the plates which were not in direct contact with water.

The pictures are also of interest from another point of view in that they well illustrate the reinforcing effect of the girth seams of a boiler shell. Although in this case the seams were overheated equally with the immediately adjacent plates, and perhaps even to a greater degree because of the greater mass of metal concentrated here, yet it can be seen that the seams did not yield to the pressure as did the plates.

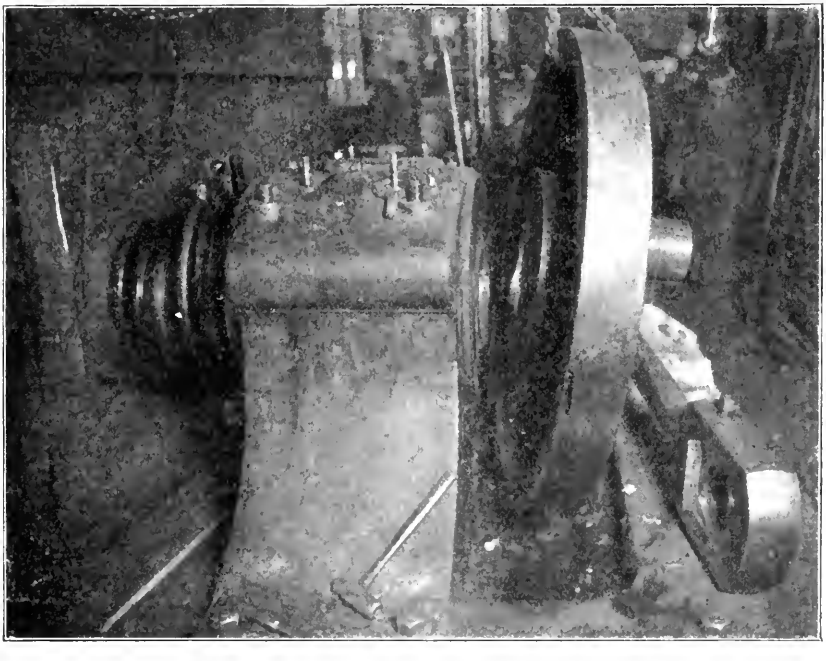
ENGINE ACCIDENT AT WILLIAMSPORT, PA.

THE accompanying pictures show the manner in which a large Corliss type engine was wrecked on February 7, 1927, at the plant of Sweet's Steel Company, Williamsport, Pa. The engine was practically a total loss, the direct property loss amounting to $10,000.

The failure occurred while the engine was operating at its normal speed of 100 r. p. m., and there were no advance indications of its imminence. Both cylinder heads were knocked out; the one from the head end traveled a distance of 65 feet and landed on the mill floor. All parts of the piston were broken, and the piston rod bent, two valve port bridges broken, the crosshead and shoes broken and bent, connecting rod bent, eccentric disks and governor belt pulley on shaft damaged, and the bed plate broken beyond repair. The engine was housed in a structure built closely about it, and further expense was incurred incident to the repair work because this structure had to be torn down, in order to install the large engine parts, and then rebuilt.

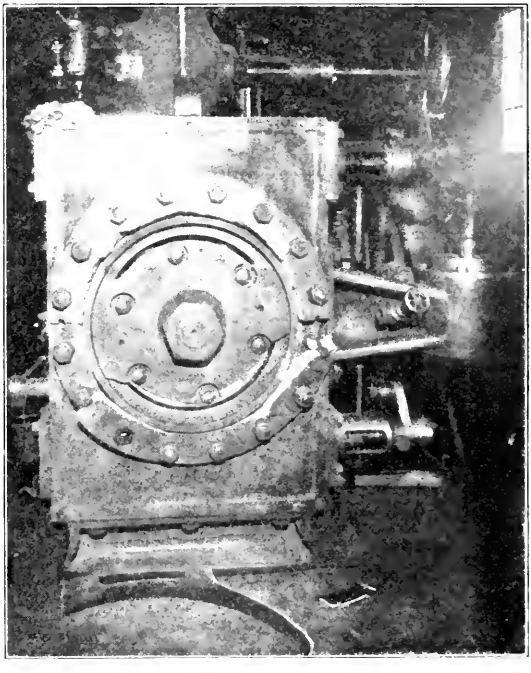
FIG. 1.

The cause of the accident was the gradual failure of the crank shaft due to continued reversals of internal stress. The failure occurred close to, and partly inside of, the face of the crank disk, at a place where a reduction in diameter of the shaft occurred. The absence of a fillet at this shoulder probably superinduced the break. The front cover picture is a view of the initial break in the shaft, and Fig. 1 is a view of the head end of the cylinder.

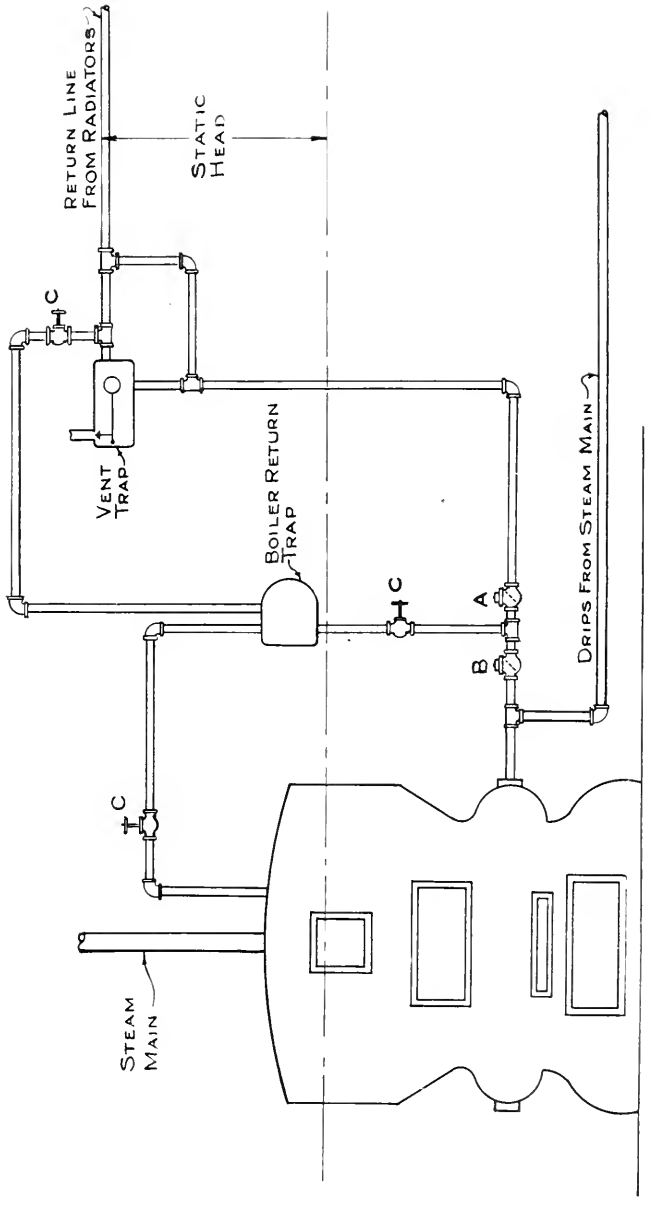
FIG. 1.

To overcome the possibility of an excessive pressure difference preventing the return of the water, a number of manufacturers have developed special boiler return traps which are designed to return the condensation to the boiler regardless of the boiler pressure, provided it is not in excess of 15 lbs. Fig. 1 shows an installation that is typical of vapor systems of the kind under consideration and illustrates how the vent trap and the return trap are connected to the system.

When a boiler return trap of this nature is used, the valves marked "C" in Fig. 1, are sometimes installed to facilitate removal of the trap in case it needs to be repaired. The closing of any one of these valves will prevent the operation of the return trap. Therefore, valves C, when used, should be locked or sealed open. It is considered advisable that the check valves shown in the diagram should be of the 45°, or swing, type rather than of the ordinary lift type.

Return traps should be installed at such a height that there will be sufficient head of water above the water line in the boiler to insure a positive and rapid flow of water from the trap into the boiler. The recommended minimum distance between the normal water line in the boiler and the bottom of the trap varies with the different makes. In all cases it is advisable to occasionally check up on the operation of the trap to see that it does promptly return the water to the boiler.
